**U.S. Army Corps of Engineers
Earthquake Preparedness Center of Expertise
Urban Search & Rescue Training**

BLOCK TITLE:	Structural Collapse Patterns
COURSE:	US&R Structures Specialist Training
BLOCK SCOPE/ OBJECTIVE:	At the end of this block, students will: Understand the principles of the ATC-21 Manual. Identify and describe problematical building types. Describe basic collapse patterns. Identify and describe earthquake collapse patterns. Describe collapse patterns caused by wind and flood.
TIME:	120 Minutes
PREREQUISITES:	Read Text Material Prior to Class
EVALUATION:	None
PERFORMANCE STANDARDS:	Full Class Attendance Completion of Practical Exercise
PREPARED BY:	Mr. David Hammond, Structural Engineer
EDITION:	3
DATE:	June 1, 1993
APPROVED BY:	EQPCE Curriculum Review Panel

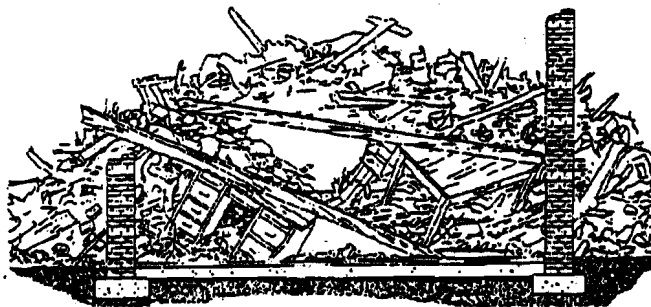
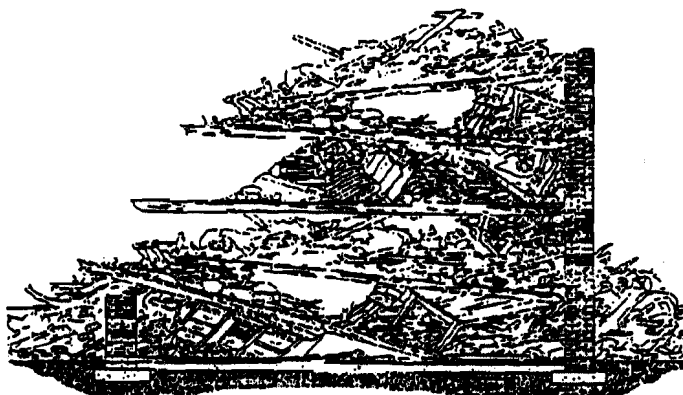
URM WALL / WOOD FLOOR COLLAPSE PATTERNS

LEAN-TO FLOOR COLLAPSE

Formed when one wall collapses, leaving other end in hazardous condition
May also occur in TU, Heavy Floor and Precast Conc.

V-SHAPE FLOOR COLLAPSE

Occurs when interior support fails. More common in urban decay/overloaded column failure
May also occur in Heavy Floor and Precast Conc. bldgs

PANCAKE FLOOR COLLAPSE

Occurs when most all vertical supporting members fail and allow floors to collapse on top of each other.
More common for Heavy Floor and Precast Conc. bldg.

CANTILEVER FLOOR COLLAPSE (pancake with extended floors)

May also occur in Heavy Floor and Precast Concrete buildings.

V-SHAPE would occur when an interior supporting wall or column fails.
